## Service Bulletin 2018-001

Issue Date: March 30, 2018

### **Subject: Upgrade reserve cover flap**

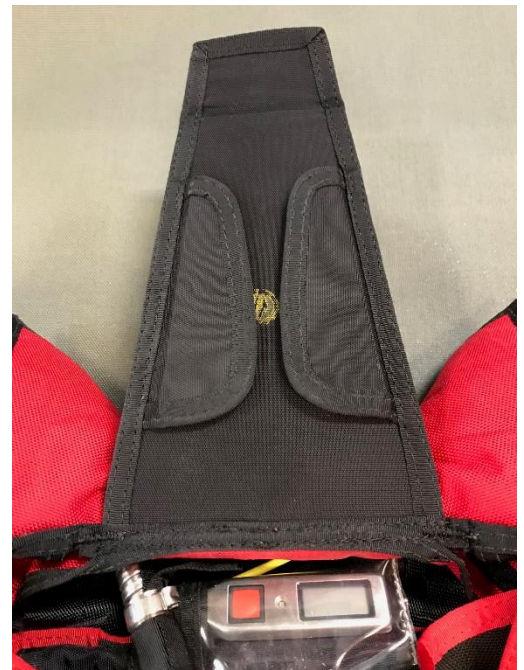
All SIFE harness & container systems after **DOM 03/18** or with the SIFE stamp on the inside of the reserve cover flap are not subject to this service bulletin.
